BELZONA TUBE SHEET AND END COVER REPAIR

ID: 31

Application: HEX-Heat Exchangers

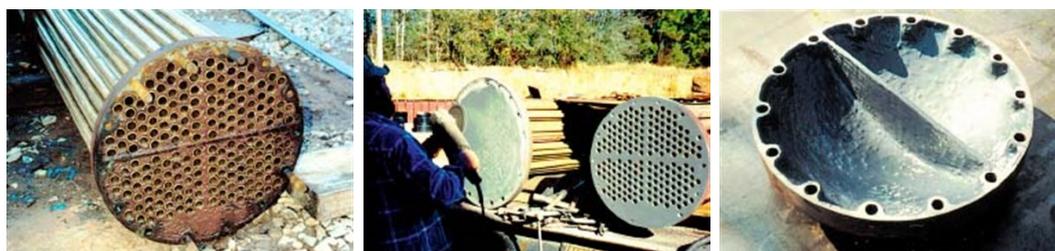
Photograph Descriptions

The tube bundle and end cover of a heat exchanger at a local refinery was badly eroded.

- * Eroded tube bundle prior to the repair ,
- * Repaired tube sheet ,
- * End cover rebuilt ,

The application was carried out in accordance with Belzona Know-How Leaflets HEX-1, HEX-2 and HEX-3.

All faces of the tube sheets were rebuilt using teflon and a steel plate as a former. The use of Belzona saved a replacement cost of approximately \$24,000.
