# BELZONA REPAIRS HYDRAULIC RAM IN SERVICE FOR OVER TEN YEARS

ID: 310

Industry: *Pulp & Paper*  
Application: *MPT-Mechanical Power Transmission*

Customer Location: *Paper Mill in Alabama, USA*  
Application Date: *1989*

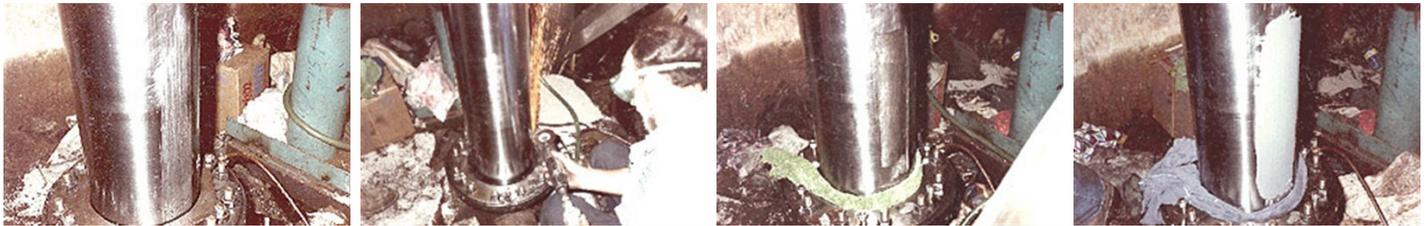
## Photograph Descriptions

*The hydraulic ram was scored due to a packing failure and was unable to build up enough pressure to raise and lower the table and transfer the stack of paper onto the conveyor system.*

- \* Scored hydraulic ram cylinder ,
- \* Surface preparation with die grinder ,
- \* Damaged area squared off ,
- \* Finished repair ,

The edges of the scores were squared off and deepened with a side grinder. Belzona® 1111 (Super Metal) was then applied to the prepared surface and dressed down with a file and emery cloth. The application has been in service for over 10 years. As long as the packing and seal area is maintained, the repair should last for a very long time.
