BELZONA RESTORES HUGE DYNAMOMETER

ID: 3116

Application: CEP-Centrifugal Pumps

Customer Location: Marine Engine Manufacturer, Croatia

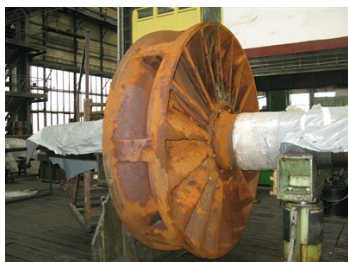
Long years in service and chloride attack degraded the surface profile of the dynamometer.

* Impeller Casing clearly showing degree of erosion present Protected impeller Protected casing ,

Application was carried out in accordance with Belzona Know-How System Leaflets CEP-1, CEP-3 and CEP-5. After the profile of the impeller and the casing had been rebuilt with Belzona® 1121, the whole dynamometer was protected with Belzona 5811. Finally Belzona® 1321 was used for extra protection for the casing and impeller blades.
