# BELZONA PROTECTS THICKENER FROM CORROSION

ID: 3126

Customer Location: Water Treatment Company, Sorocaba, Brazil

Drum thickener in waste water treatment process

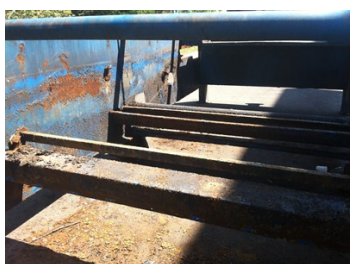
In just six months of use the equipment was already showing signs of corrosion from corrosion and chemical attack from the waste water sludge

- \* Corroded thickener ,
- \* Surface washed and grit blasted ,
- \* Coating detail items ,
- \* Completed application ,
