BELZONA PROTECTS THICKENER FROM CORROSION

ID: 3126

Customer Location: Water Treatment Company, Sorocaba, Brazil

Application: TCC-Tanks and Chemical Containment Areas

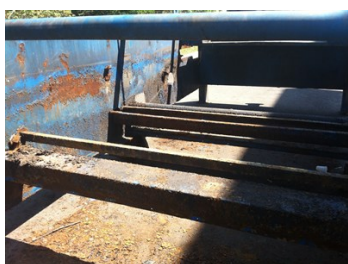
In just six months of use the equipment was already showing signs of corrosion from corrosion and chemical attack from the waste water sludge

- * Corroded thickener ,
- * Surface washed and grit blasted ,
- * Coating detail items ,
- * Completed application ,
