# BELZONA CONTAINS 98% SULPHURIC ACID

**Industry:** Chemical & Petrochemical  
**Application:** TCC-Tanks and Chemical Containment Areas  
**Substrate:** Concrete  
**Products:** \* Belzona® 4311 (Magma CR1) ,

**Customer Location:** Chemical Plant, Porto Feliz, Brazil  
**Application Date:** November 2011

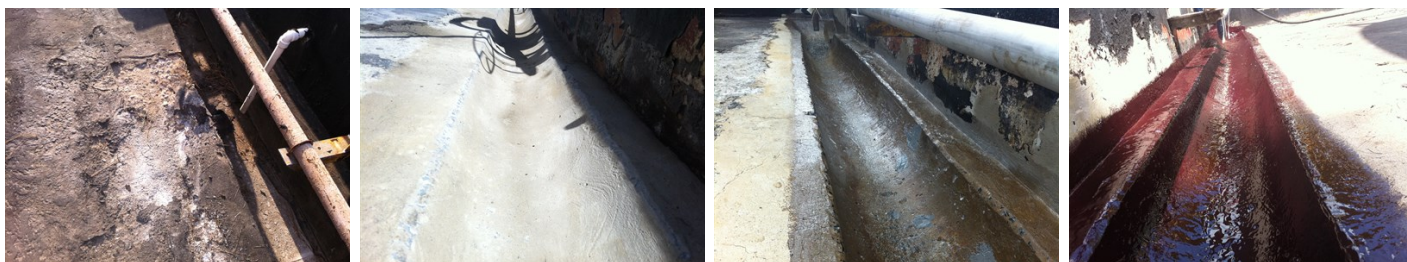
*Previously used coatings had failed allowing the acid to attack the underlying concrete.*

- \* Failure of previously used coating ,
- \* Surface prepared ,
- \* Substrate conditioned with Belzona® 4911 ,
- \* Finished job ,

Application was carried out in accordance with Belzona Know-How System Leaflet TCC-15. Old coating was removed and damaged concrete rebuilt with new concrete. After drying out for 28 days 2 coat system of Belzona® 4311 was applied.
