BELZONA STOPS PREMATURE WEAR ON THIS RUBBER BELT

ID: 313

Industry: *Mining & Quarrying*
Application: *SHM-Solids Handling Machinery*

Conveyor belt clips from a dredger.

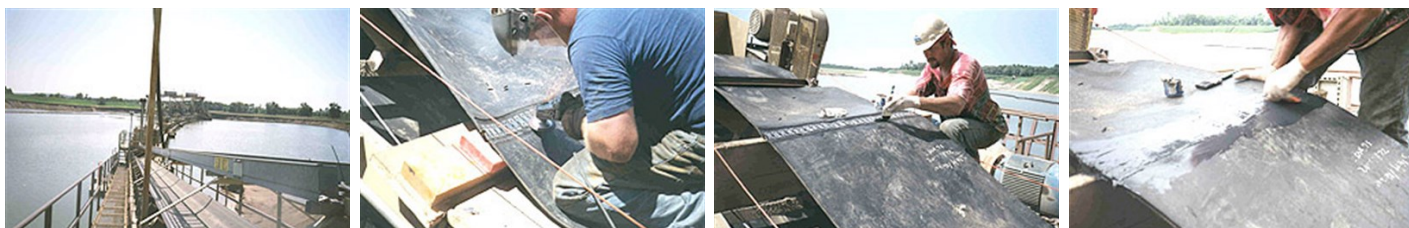
Photograph Descriptions

Gravel from the quarrying operation was wearing the clips out prematurely and creating unscheduled outages.

* View of conveyor belt from dredger Grinding down edges of new clips Conditioning repair area with Belzona® 2911 (QD Conditioner) Application of Belzona® 2211 (MP Hi-Build) ,

The application was carried out in accordance with Belzona Know-How System Leaflet SHM-4.

The repair was not put on too thick because of scraper arm concerns and flapping over the drive roller.
