BELZONA REPAIRS CONVEYOR BELT WITH MINIMAL DOWNTIME

ID: 314

Application: *SHM-Solids Handling Machinery*

Customer Location: *Pulp mill in Florida U.S.A.*

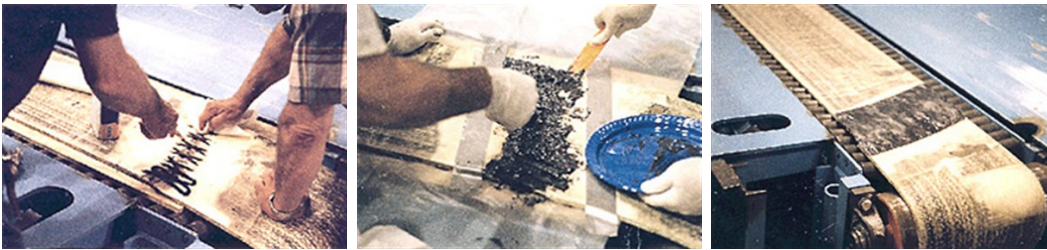
Photograph Descriptions

The lap joint on a relatively new PVC belt in the finishing area of a chemical cellulose manufacturer had failed. When this system breaks down, the mill is unable to get product through the finishing area and out to customers.

- * Cleaning and degreasing conveyor belt, lacing in place ,
- * Applying Belzona® 2311 (SR Elastomer) ,
- * Finished application with belt in service ,

PVC conveyor belt lap joint.

The application was carried out in accordance with Belzona Know-How System Leaflet SHM-3.

Permanent repair was made to the lap joint with Belzona® 2311 (SR Elastomer) that has USDA approval for incidental food contact during the lunch hour.
