# BELZONA REPAIR TO FERRY'S PROPULSION SYSTEM

ID: 3159

Voith Schneider propulsion unit of a ferry.

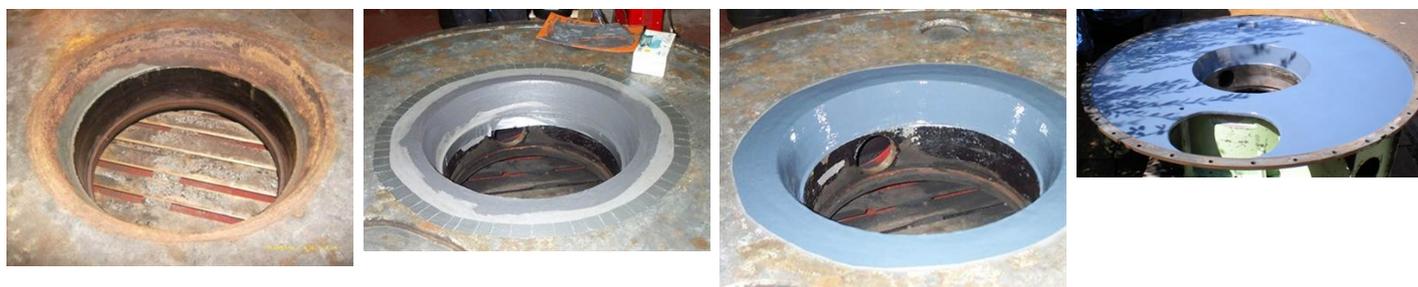
*Erosion-corrosion on the face and bore of the casing, due to sea water corrosion and erosion from entrained sand. If allowed to continue the casing could be perforated leading to oil leakage.*

- \* Close view of the erosion-corrosion problem ,
- \* Eroded areas rebuilt with Belzona® 1311 ,
- \* Application of a final blue coat of Belzona® 1341 to protect the casing against further erosion-corrosion problems ,
- \* 2009 application - Belzona® 1341 applied on the casing ,

Application was carried out in accordance with Belzona Know-How System Leaflets SOS-1 and SOS-2. Pitted areas were rebuilt with Belzona® 1311 before receiving 2 coats Belzona® 1341 for overall erosion-corrosion protection.
