BELZONA SAVES SEVERAL WEEKS OF DOWNTIME

ID: 316

Application: *SHM-Solids Handling Machinery*

Customer Location: *Paper mill in Canada*

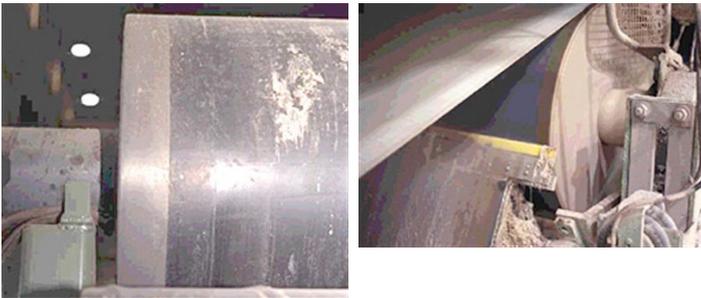
Photograph Descriptions

The rubber lined felt rolls are damaged from continuous abrasive wear of the wires edge and underside. This eventually causes sheet stretching and/or wrinkling.

- * Final rectification of Belzona repair ,
- * Felt roll back in service ,

Putting a new rubber cover on a roll is very expensive and the roll is usually out of service for weeks. The hardness of the Belzona repair must be close to the hardness of the rubber. In this case Belzona® 1111 (Super Metal) is 89 Shore D, or a P&J hardness between 8 and 9.
