BELZONA RESTORES THE PROPER SURFACE PROFILE TO A PRESS ROLL

ID: 318

Industry: *Pulp & Paper*
Application: *SHM-Solids Handling Machinery*

Substrate: *Rubber lined steel*
Products: ** Belzona® 1111 (Super Metal) ,*

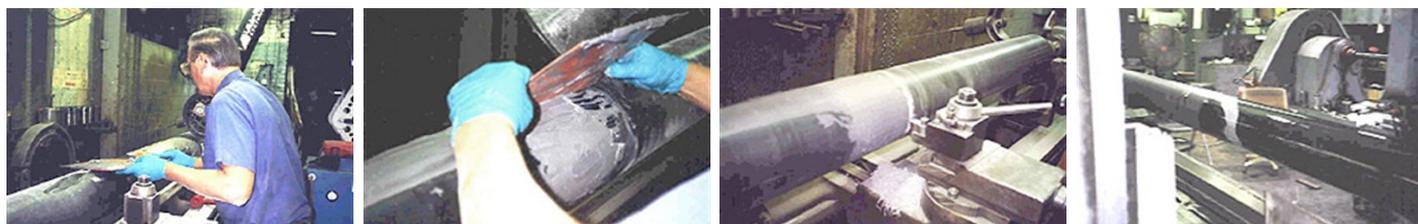
Belzona® 1111 (Super Metal) was used to repair the damaged surface of the press roll after a metal bolt had gone through the machine. The roll was then unable to remove water from the paper. This produced poor quality paper and resulted in breaks.

- * Applying Belzona® 1111 (Super Metal) to damaged press roll ,
- * Removing excess Belzona from repair area ,
- * Machining repair to tolerances ,
- * Final rectification to maintain proper surface finish. ,

After an initial cure of 2-hours, the material was machined and subsequently rectified to obtain the appropriate surface finish. Belzona® 1111 (Super metal) P&J hardness of between eight and nine closely matched the existing rubber hardness of the roll.
