BELZONA REPAIRS AND ENHANCES CONCRETE CLARIFIER TROUGHS

Customer Location: Wastewater treatment plant in
Plantation, Florida USA

Application: TCC-Tanks and Chemical Containment
Areas

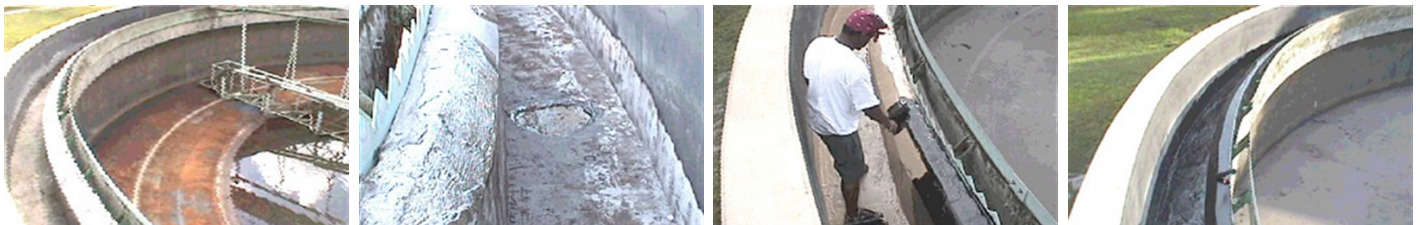
Photograph Descriptions

An old coal tar epoxy system had failed and resulted in damage to the underlying concrete. It also made it very difficult to keep the trough clean and free from algae buildup.

- * Clarifier drained to affect repairs ,
- * Concrete damage from failure of coal tar epoxy system ,
- * Application of second coat of Belzona® 5811 (Immersion Grade) ,
- * Finished application. ,

80-ft diameter concrete clarifier trough.

The application was carried out in accordance with Belzona Know-How System Leaflets TCC-9 and TCC-15.
