BESCHICHTUNG DER INNEN- UND AUSSENFLÄCHEN EINER ROHRGEHÄUSEPUMPE MIT BELZONA

ID: 3206

Industrie: Ölbenzin
Anwendung: Kreiselpumpen
Substrat: Aluminiumbronze
Produkte: * Belzona 1341N (Supermetalglide) ,
* Belzona 1111 (Super Metal) ,

Standort des Kunden: Ölunternehmen, Saudi-Arabien
Antragsdatum: April 2007

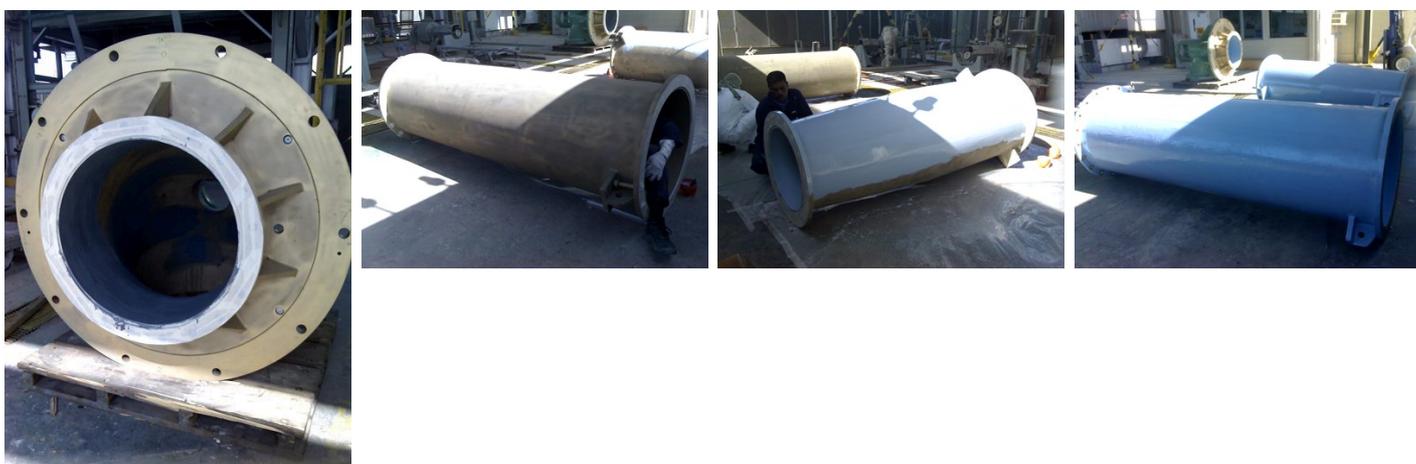
Fotobeschreibungen

Die Rohrgehäusepumpe einer Raffinerie wies an den Innen- und Außenflächen Erosions- und Korrosionsschäden auf.

- * 1. Wiederaufbau des Pumpenkopfs ,
- * 2. Sandgestrahltes Rohr ,
- * 3. Außenbeschichtung der Rohre ,
- * 4. Abgeschlossene Anwendung ,

Die Anwendung wurde gemäß den Belzona Know-how System Infoblättern CEP-3 und -5 durchgeführt.

Die bisherige, ein Jahr zuvor aufgetragene Beschichtung versagte bereits nach einem Jahr. Der Kunde ist zuversichtlich, dass die

Pumpe dank Belzona die angestrebte Lebensdauer erreichen kann.
