# BELZONA KEEPS CHEMICALS CONTAINED

Industry: *Pulp & Paper*  
Application: *TCC-Tanks and Chemical Containment Areas*  
Substrate: *Concrete*  
Products: *\* Belzona® 4311 (Magma CR1) ,*

Customer Location: *Pulp and paper mill in Mississippi, USA*  
Application Date: *1995*

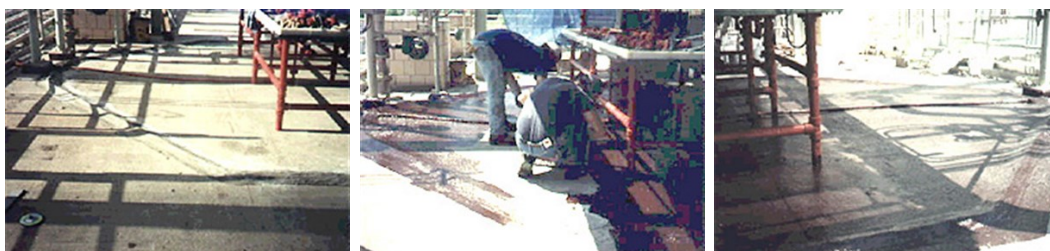
*Sodium sulfate as well as some sulfuric acid is used to control the pH as well as sulfur content in the cooking liquor. This sulfuric acid mixing station suffered from acid deterioration and actually contaminated the paper making stock below.*

- \* Deteriorated sulfuric acid mixing station floor ,
- \* First coat of Belzona® 4311 (Magma CR1) ,
- \* Finished application ,

The application was carried out in accordance with Belzona Know-How System Leaflet TCC-15. After pressure washing and neutralizing the containment area with soda ash, two coats of Belzona® 4311 (Magma CR1) was applied by brush and roller.
