BELZONA FOR EMERGENCY LEAK SEALING

ID: 323

Customer Location: Water treatment plant in North Florida,
U.S.A.

Application: WPA-Wall Problem Areas

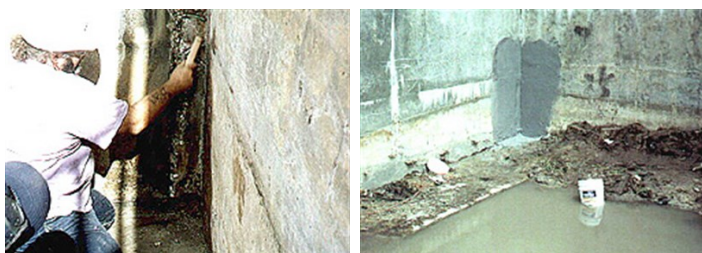
Leaking in the joint between a new, and existing tank. Loss of water estimated at one million gallons per month.

- * Cleaning away old concrete ,
- * The completed repair ,

Wall of a filter/settling tank.

The application was carried out in accordance with Belzona Know-How System Leaflet WPA-7.

This repair was carried out with a stream of water flowing out of the crack. Because of the anticipated movement in this joint, the repair was expected to be temporary. It did, in fact begin leaking some time later, but at a much reduced rate. When the tank is drained, a more permanent Belzona repair will be carried out.
