ABSORBER REPAIRED AND PROTECTED WITH BELZONA

ID: 3240

Application: TCC-Tanks and Chemical Containment Areas

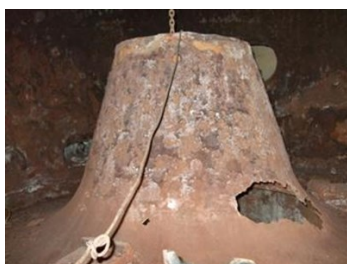
The bubbler throat on the absorber had developed a number of holes within the vessel compartment due to substrate erosion/corrosion.

* Absorber throat extensively damaged by corrosion Steel plates being bonded onto the absorber using Belzona® 1121 Cold bonding completed Completed application with Belzona® 1391 coating applied. ,

Badly corroded throat area in absorber.

Application was carried out in accordance with Belzona Know-How System Leaflets TCC-1 & TCC-5. A total of 16 handleable sections of pre-formed mild steel plate were cold bonded to the substrate using Belzona® 1121 to completely encapsulate the affected areas. Once the Belzona had cured, the plates were frost blasted and the entire repair area was protected with Belzona® 1391 to prevent further damage.
