BELZONA PERMANENTLY SECURES HANDRAIL POSTS

Customer Location: Municipal sewage treatment facility in Minnesota, USA

Application: FPA-Floor Problem Areas

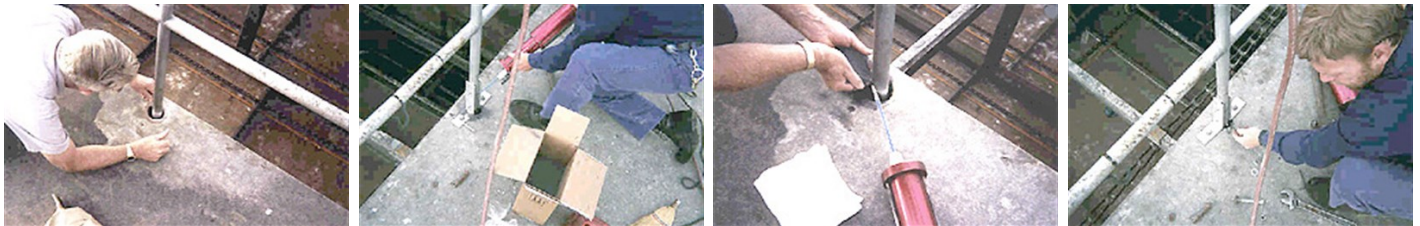
Photograph Descriptions

Liquid was pooling around these handrails, spalling the concrete and loosening the rails at this municipal sewage plant to such an extent that worker safety was in question.

- * Removing loose debris from the handrail post/concrete interface ,
- * Injecting Belzona® 4151 into the handrail post hole ,
- * Filling in the irregularity with the aggregate ,
- * Finished repair by mounding the resin to the shed water ,

Spalled concrete around handrail posts at a sewage treatment plant.

The application was carried out in accordance with Belzona Know-How System Leaflets FPA-10.

Other cementitious-based repair materials shrink and crack, often allowing liquid a path to migrate through. This causes further spalling in a relatively short period of time.
