# BELZONA REPAIRS SPALLED CONCRETE ON THIS AERATION TANK

Customer Location: County wastewater plant in Northern Florida, U.S.A.

Application: FPA-Floor Problem Areas

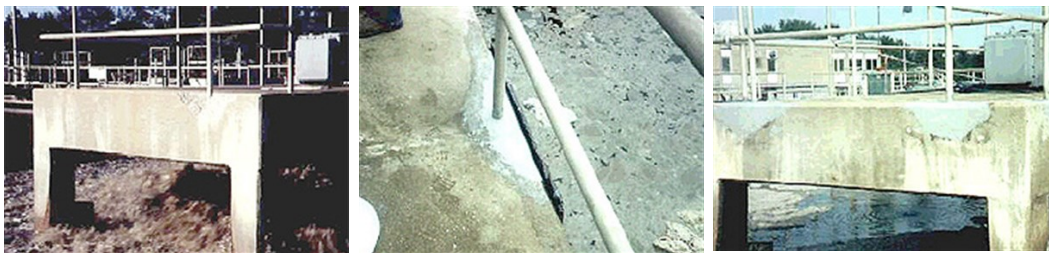
*Deteriorated concrete around the base of the handrail posts raised safety concerns.*

- \* Severely spalled concrete around handrail post ,
- \* Repair of both sides and run at base of handrail post ,
- \* Overall view of repaired deterioration ,

Spalled concrete at railings along a platform perimeter above an aeration tank.

The application was carried out in accordance with Belzona Know-How System Leaflet FPA-10.

Patching the concrete did not work, since the old and new concrete did not bond well. This allows water to migrate through the repair, causing the same deterioration of the concrete as before. Replacing the slab would cost thousands of dollars as well as the interruption of the aeration tank process.
