# BELZONA ELIMINATES POTENTIAL SAFETY HAZARD

ID: 330

Customer Location: *Municipal wastewater treatment facility  
in Northern Florida, U.S.A.*

Application: *TCC-Tanks and Chemical Containment  
Areas*

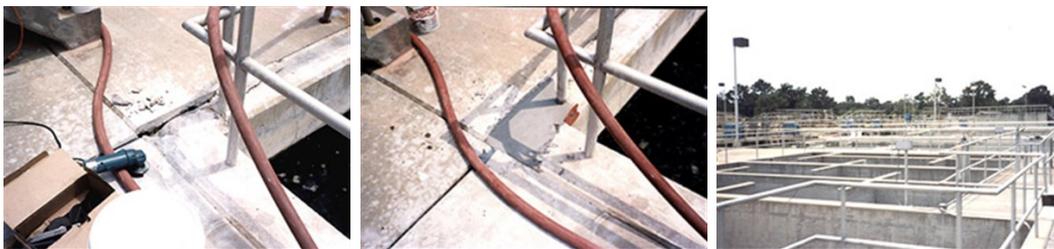
*The damaged concrete at a handrail post was creating a potential safety hazard.*

- \* Severely spalled concrete adjacent to handrail post-surface preparation in progress ,
- \* Repair at base of handrail post ,
- \* Overall view of repaired area ,

Spalled concrete at handrail post of a clarifier in a wastewater treatment plant.

The application was carried out in accordance with Belzona Know-How System Leaflet TCC-9.

This is a convenient and cost effective repair. The alternative was to pour and reform the concrete. The customer saved several thousand dollars. Other concrete patch materials are porous and the same degradation scenario would ultimately occur.
