BELZONA SHAFT REPAIR AT STEEL MILL

ID: 3316

Worn shafts in steel rolling mill

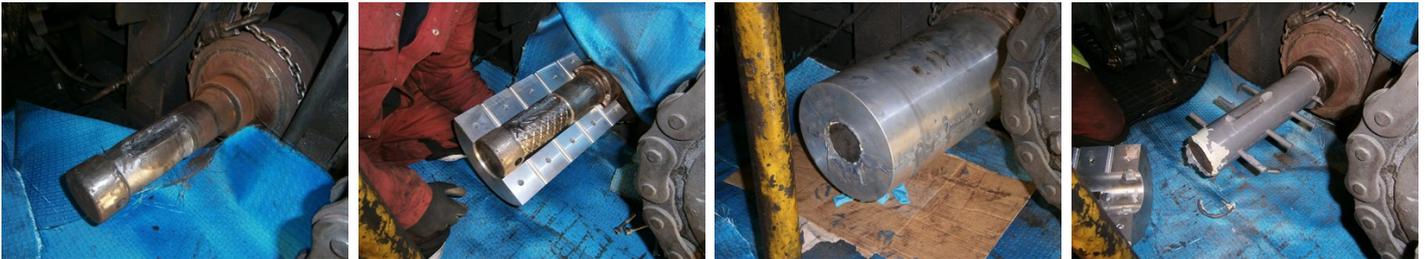
Photograph Descriptions

Heavy wear on the drive locations led to excessive downtime for the customer

- * Worn shaft prior to Belzona repair ,
- * Surface preparation carried out and the bottom former in place on the shaft ,
- * Former clamped in position and filled with Belzona® 1111 ,
- * Former removed revealing fully cured Belzona® 1111 prior to dressing down ,

Application was carried out in accordance with Belzona Know-How System Leaflet MPT-2. After thorough surface preparation, the Belzona® 1111 was applied by brush to the repair area. Next, a pre-made split former was clamped over the repair and additional Belzona® 1111 was injected via ports. The material was allowed to cure fully before the former was removed and the repair dressed down before returning to service
