# SCRUBBER FILTER FRAMES REPAIRED PROTECTED WITH BELZONA

ID: 3317

Customer Location: *Phosphoric acid producer, Morocco*

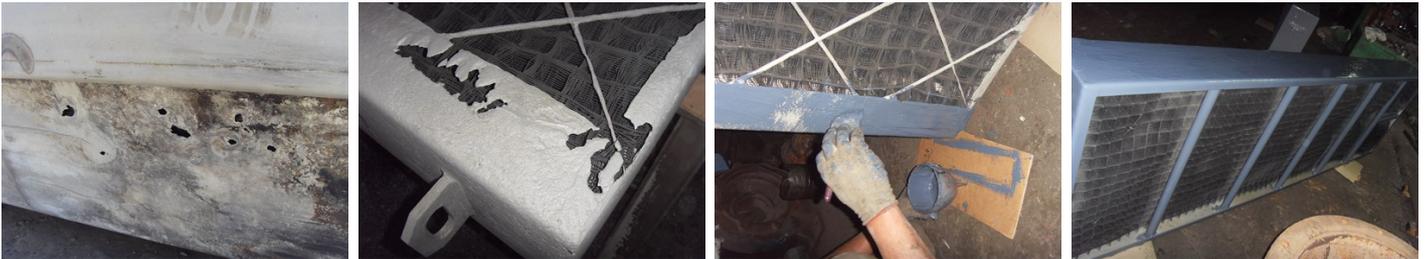
*The environment contains up to 2,6 mg/Nm<sup>3</sup> phosphoric acid which leads to severe corrosion problems.*

\* Scrubber filter frame before the application Filter frame gritblasted Application in progress Application to one of the scrubber filter frames completed. ,

20 scrubber filter frames from a gas filtering unit. Each unit made from 316L stainless steel had a surface area of 2.9m<sup>2</sup>.

The application was carried out in accordance with Belzona Know-How System Leaflet TCC-5. For the coating application, the standards DIN 28051, 28053 and 55128 were applied. Before the application, the surfaces were gritblasted to a minimum depth of profile of 75 microns.

The customer already knew Belzona and wanted to protect his filters with Belzona® 1321 which has the required acid and erosion resistance. The filters were repaired and protected in just three days which met the clients tight schedule.
