# BELZONA REPAIRS IRRIGATION PIPES

ID: 333

**Industry:** General Industry  
**Application:** VPF-Valves, Pipes and Fittings  
**Substrate:** Aluminum Alloy  
**Products:** \* Belzona® 1221 (Super E-Metal) ,  
\* Belzona® 9341 (Reinforcement tape) ,

**Customer Location:** Arable farm in the U.K.  
**Application Date:** May 1995

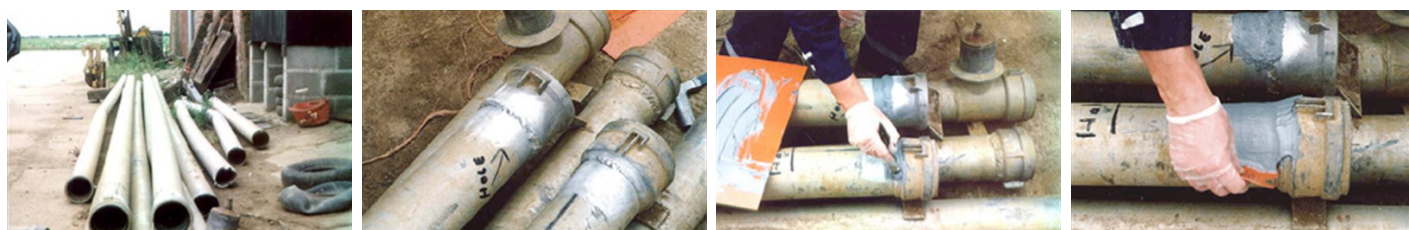
## Photograph Descriptions

*Pipes develop leaks at welded couplings and weld repairs have proven ineffective and in several cases aggravated the situation.*

- \* Sections of pipe waiting to be used ,
- \* Close up of pipe couplings where leaks occur and show ineffective welding ,
- \* Belzona® 1221 (Super E-Metal) being applied ,
- \* Application being completed with Belzona® 9341 (Reinforcement Tape) incorporated into the repair ,

The application was carried out in accordance with Belzona Know-How System Leaflet VPF-11a.

Local flooding caused by the leaks leads to loss of crops in the immediate vicinity, apart from overall loss in irrigation efficiency. Belzona® 1221 (Super E-Metal) is ideal for carrying out in-situ repairs when necessary.
