BELZONA REPAIRS IRRIGATION PIPES

ID: 333

Industry: General Industry
Application: VPF-Valves, Pipes and Fittings
Substrate: Aluminum Alloy
Products: * Belzona® 1221 (Super E-Metal) ,
* Belzona® 9341 (Reinforcement tape) ,

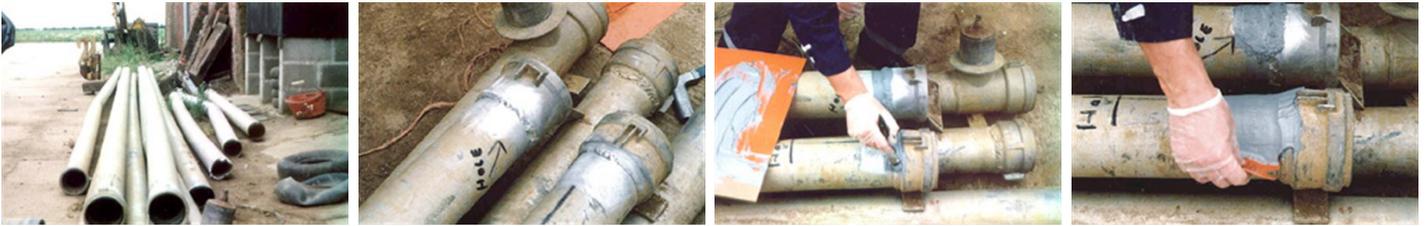
Photograph Descriptions

Pipes develop leaks at welded couplings and weld repairs have proven ineffective and in several cases aggravated the situation.

- * Sections of pipe waiting to be used ,
- * Close up of pipe couplings where leaks occur and show ineffective welding ,
- * Belzona® 1221 (Super E-Metal) being applied ,
- * Application being completed with Belzona® 9341 (Reinforcement Tape) incorporated into the repair ,

The application was carried out in accordance with Belzona Know-How System Leaflet VPF-11a.

Local flooding caused by the leaks leads to loss of crops in the immediate vicinity, apart from overall loss in irrigation efficiency. Belzona® 1221 (Super E-Metal) is ideal for carrying out in-situ repairs when necessary.
