PIPING DISTRIBUTION HEADER REPAIRED WITH BELZONA

ID: 335

Customer Location: Water treatment plant in Florida, USA

Application Date: May 1999

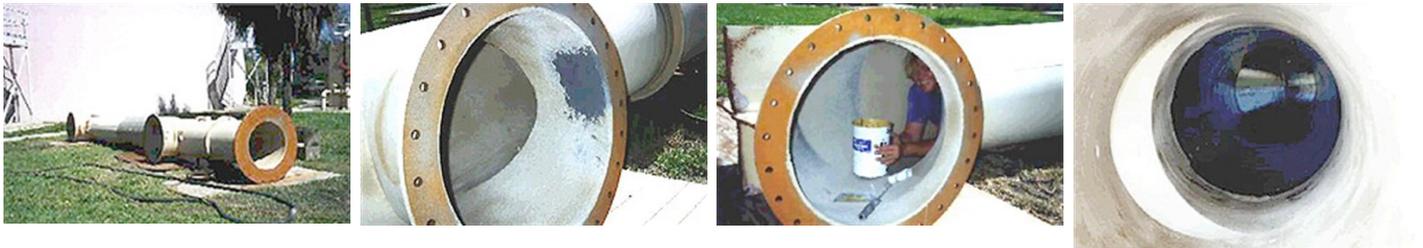
Photograph Descriptions

Corrosion as well as erosion deteriorated the entire internal surface of this sludge water piping structure. This pipework transports sludge water from the sedimentation tanks to the digester.

- * View of the sedimentation tanks ,
- * Repairs to pits with Belzona® 1111 (Super Metal) ,
- * First coat Belzona® 5811 (Immersion Grade) ,
- * Second coat of Belzona® 5811 (Immersion Grade) almost complete ,

The application was carried out in accordance with Belzona Know-How System Leaflets VPF-1 and VPF-2.

Belzona® 5811 (Immersion Grade) is perfectly suited to resist mild erosion coupled with H₂S attack. Replacing piping can be very difficult if the new section does not line up with the old flange face.
