# FÖRDERBAND-REPARATUR MIT BELZONA

ID: 3361

Standort des Kunden: Kraftwerk, Bulgarien

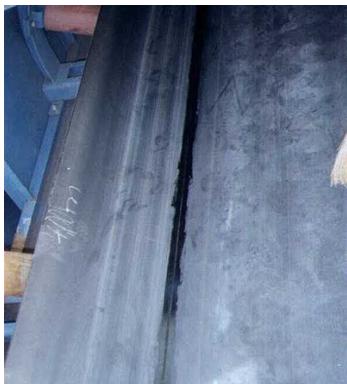
Durch einen mechanischen Schaden am Bandabstreicher wurde die Metallverstärkung freigelegt.

- \* 1. Ansicht der Förderanlage ,
- \* 2. Grundierung mit Belzona 2911 (Elastomer QD Conditioner) ,
- \* 3. Reparatur mit Belzona 2311 (SR Elastomer) ,

Für den Kunden war bei der Reparatur vor allem eine möglichst kurze Ausfallzeit entscheidend. Belzona wurde aufgrund seiner im Gegensatz zur Vulkanisation effektiven, einfachen und schnellen Anwendung ohne Spezialwerkzeuge gewählt.
