# BELZONA IS THE IDEAL SOLUTION FOR WEAR RING REBUILDS

**Industry:** General Industry  
**Application:** CEP-Centrifugal Pumps  
**Substrate:** Cast iron  
**Products:** \* Belzona® 1111 (Super Metal) ,  
\* Belzona® 9411 (Release Agent) ,

**Customer Location:** Machine shop in North Florida, U.S.A.  
**Application Date:** July 1995

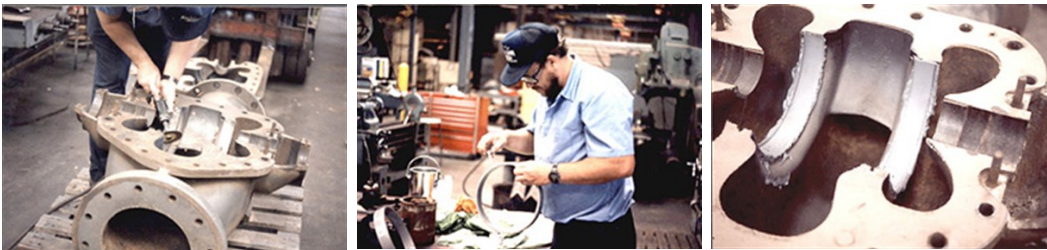
*The wear ring seat clearances have deteriorated from dissimilar metal corrosion and caused poor pump performance from loss of pump tolerances.*

- \* Surface preparation using a side grinder ,
- \* Belzona® 9411 (Release Agent) being applied to new wear rings ,
- \* New seats formed with Belzona® 1111 (Super Metal) ,

The reforming of wear ring seats is a standard repair procedure that does not use uncontrolled heat treatments or specialized machining techniques to achieve a proper fit. By eliminating galvanic effects, the working life of this pump has been dramatically extended.
