BELZONA IS THE IDEAL SOLUTION FOR WEAR RING REBUILDS

ID: 339

Industry: General Industry
Application: CEP-Centrifugal Pumps
Substrate: Cast iron
Products: * Belzona® 1111 (Super Metal) ,
* Belzona® 9411 (Release Agent) ,

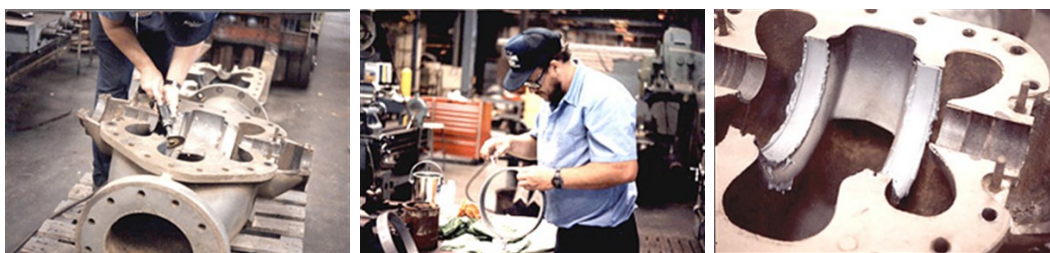
Photograph Descriptions

The wear ring seat clearances have deteriorated from dissimilar metal corrosion and caused poor pump performance from loss of pump tolerances.

- * Surface preparation using a side grinder ,
- * Belzona® 9411 (Release Agent) being applied to new wear rings ,
- * New seats formed with Belzona® 1111 (Super Metal) ,

The reforming of wear ring seats is a standard repair procedure that does not use uncontrolled heat treatments or specialized machining techniques to achieve a proper fit. By eliminating galvanic effects, the working life of this pump has been dramatically extended.
