CHEMICAL ATTACK AND GALVANIC CORROSION STOPPED WITH BELZONA

Industry: *Pulp & Paper*
Application: *CEP-Centrifugal Pumps*
Substrate: *Cast iron*
Products: ** Belzona® 1111 (Super Metal) ,*

Customer Location: *Paper mill in Georgia, USA*
Application Date: *March 2000*

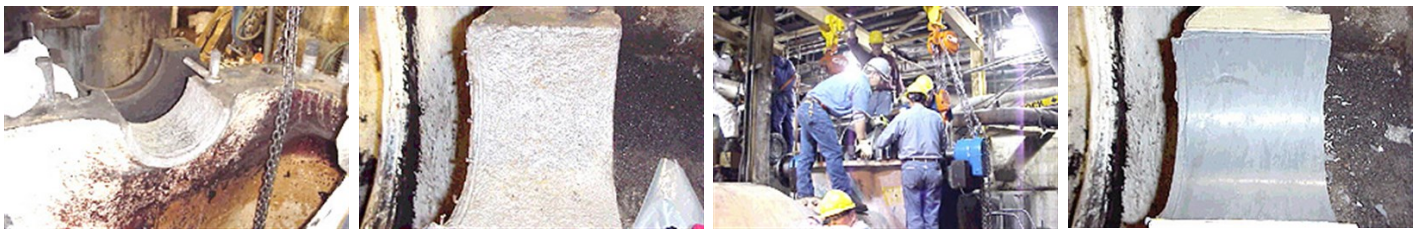
White water chemical attack, coupled with galvanic corrosion caused this large Goulds primary fan pump's stuffing box to deteriorate.

- * Damage stuffing box of large centrifugal pump ,
- * Galvanic damage to stuffing box shoulder ,
- * Rotating assembly dropped into the wet Belzona ,
- * Stuffing box completely rebuilt with Belzona® 1111 (Super Metal) ,

The application was carried out in accordance with Belzona Know-How System Leaflet CEP-2.

Goulds pumps actually manufactured a special sleeve and instructed the mill to use Belzona® 1111 (Super Metal) until such time as a replacement pump could be manufactured and delivered (three weeks).
