# BELZONA SOLVES CORROSION LEAKS ON TRANSFORMER LV TURRET

Industry: Power  
Application: TCC-Tanks and Chemical Containment Areas

Customer Location: Electricity Substation, South Coast, UK  
Application Date: April 2012

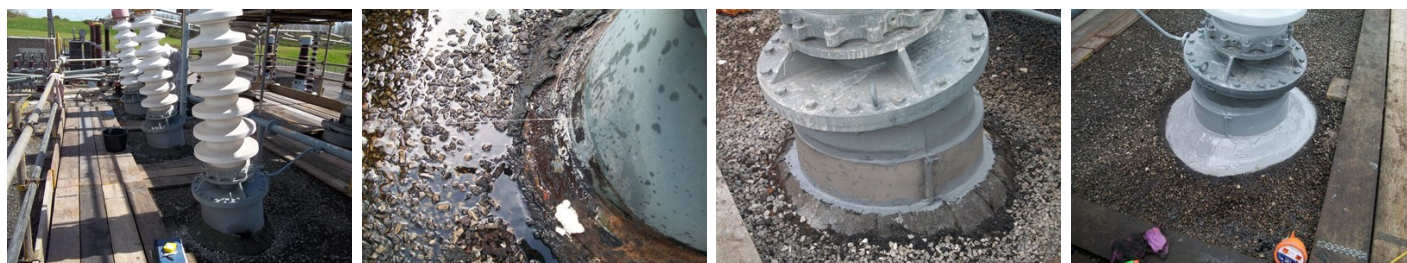
Corrosion and oil discharges were observed to the LV Turrets which indicated through wall penetration, placing the asset at high risk of internal contamination. Upon removing bituminous membrane, exposed metal corrosion and active oil discharges from Turret were identified.

- \* Location of three LV Turrets ,
- \* Corrosion and live leak oil discharge ,
- \* Plate bonding ,
- \* Work completed on one of the Turrets ,

Application was carried out in accordance with Belzona Know-How System Leaflets FBC-6, TCC-1 & RPA-1. After isolating the oil conservator tank and marking area of repair to each Turret, the bituminous coating to the base was removed. Substrate degreased and prepared by MBX and hand abrasion. All live leaks were stemmed using Belzona® 1291. Doubler plate covering the Turret circumference/base bonded in place with Belzona® 1161. Once cured, Belzona® 5831 applied to provide corrosion protection and finally Belzona® 3121 applied to seal full circumference of Turret to roof joint.
