# BELZONA SEALS SPY GLASSES IN VESSEL

ID: 3415

Industry: *General Industry*  
Application: *TCC-Tanks and Chemical Containment Areas*  
Substrate: *Steel*  
Products: *\* Belzona® 4301 (Magma CR1 Hi-Build),*

Customer Location: *International chemical company, Spain*  
Application Date: *April 2012*

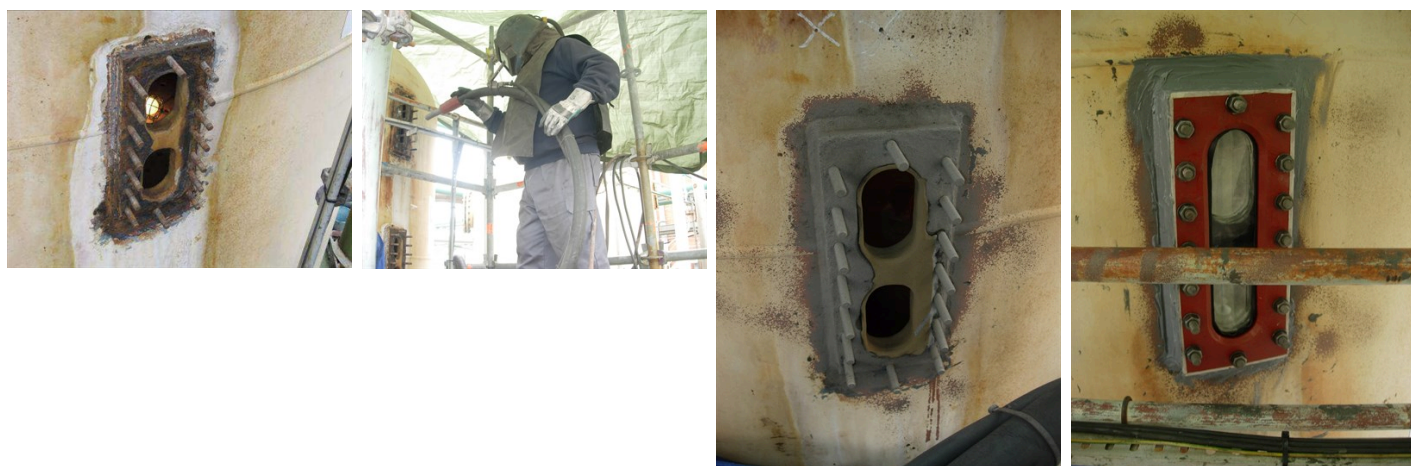
*Corrosion had occurred at the spy glasses caused by the Hydrochloric acid used during the regeneration process.*

- \* Spy glass before the application ,
- \* Grit blasting in progress ,
- \* Surface preparation completed ,
- \* Application completed ,

The application was carried out in accordance with Belzona Know-How System Leaflet TCC-5. After grit blasting the surface and protecting areas where Belzona should not adhere (nuts, bolts, cover) with two coats of Belzona® 9411 (Release Agent) Belzona® 4301 applied to rebuild lost profiles, restore corrosion protection allowing the site glasses to be effectively sealed. .
