BELZONA RELINES WATER PUMP

ID: 3417

Customer Location: Water treatment Plant, Stavanger, Norway

Application: CEP-Centrifugal Pumps

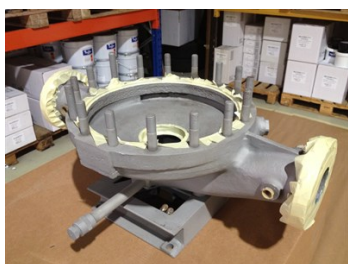
- * Grit blasted pump prior to application ,
- * Rebuilding internal damaged areas ,
- * Finished application ,
- * Pump and parts coated internal and external prior to return to client ,
