# BELZONA RELINES WATER PUMP

Customer Location: Water treatment Plant, Stavanger,  
Norway

Application: CEP-Centrifugal Pumps

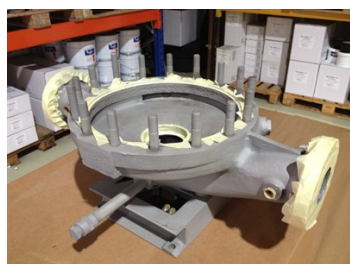
The pump was suffering erosion/corrosion after 3 years in service due to total breakdown of existing unknown coating.

- \* Grit blasted pump prior to application ,
- \* Rebuilding internal damaged areas ,
- \* Finished application ,
- \* Pump and parts coated internal and external prior to return to client ,

Application was carried out in accordance with Belzona Know-How System Leaflets CEP-3 & CEP-5.
