BELZONA PROTECTS NEWLY CONSTRUCTED PLANT ROOM

ID: 3419

Customer Location: *University, Wolverhampton, UK*
Application Date: *May 2012*

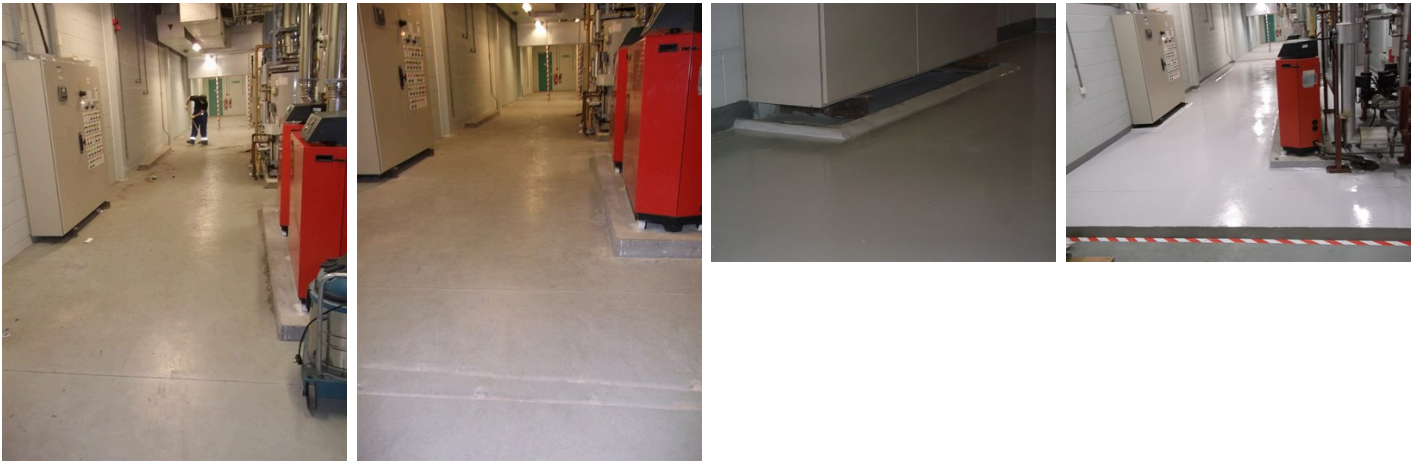
Photograph Descriptions

Plant room required protection from the possibility of water leaks and flooding to other areas.

- * Clearing of plant room floor ,
- * Floor abraded in preparation for Belzona® 4131 bund and fillets ,
- * Section of banded area ,
- * Completed plant room floor bund after coating with Belzona® 5231 ,

Newly constructed plant room at the University.

Application was carried out in accordance with Belzona System Leaflets FPA-3 and TCC-15. Belzona® 4131 was used to create raised banded areas and covings before applying Belzona® 5231 to completely seal the floor area.

The customer had already experienced floods in other unprotected plant rooms and knew Belzona would be able to create the necessary protection required. The Belzona® 4131 enabled the construction of a raised containment area for spills for sealing with the impermeable Belzona® 5231. This coating has the added benefit of containing a non-slip aggregate improving the safety of the plant room when floor is wet.
