REPAIR AND PROTECTION OF FOUNDRY SAND MIXERS WITH BELZONA

ID: 3428

Application: *SHM-Solids Handling Machinery*

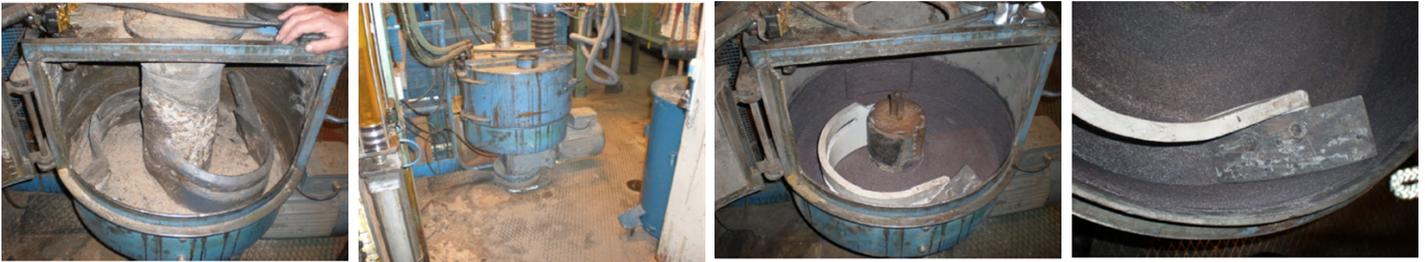
Photograph Descriptions

Severe wear on the bottom as well as the lower part of the inside walls/sides where the mixer arm passes and scrape along the sides.

- * The damaged sand mixer ,
- * An overview of the sand mixer ,
- * After the finished application of Belzona® 1812 ,
- * An applicator mounted on the mixer arm to achieve the required profile ,

Application was carried out in accordance with Belzona System Leaflet SHM-13. Belzona 1812 was used to repair and protect the exposed surfaces. The rotating mixer arm was used to make sure the bottom and the lower parts of the sides in the mixer were even and correct clearances achieved.
