BELZONA KEEPS THIS PASSENGER FERRY RUNNING SMOOTHLY

Industry: Marine
Application: SOS-Ships and Offshore Structures

Customer Location: Ferry operator, British Columbia, Canada
Application Date: April 2002

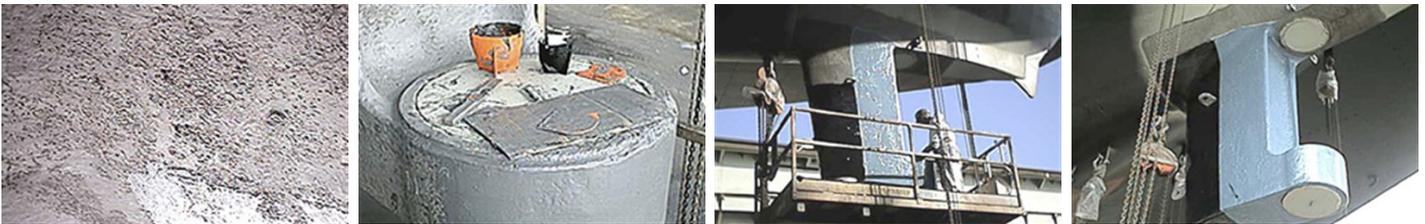
Photograph Descriptions

The sides and trailing surfaces of this large rudder horn suffered from cavitation and significant metal loss.

- * Cavitation clearly evident ,
- * Rebuilding with Belzona® 1121 (Super XL-Metal) ,
- * Belzona® 2141 being applied ,
- * Final application ,

The application was carried out in accordance with Belzona Know-How System Leaflets SOS-1 and SOS-2.

Belzona® 2141 has exhibited excellent cavitation resistance as document-ed by the ARL at Penn State. Alternatively, you would have to weld up hundreds of damaged areas or cut out a large section and weld in new plate.
