# BELZONA SEALS CRACKS IN UNDERWATER CONCRETE TANK

**Industry:** Water / Wastewater  
**Application:** TCC-Tanks and Chemical Containment Areas  
**Substrate:** Concrete  
**Products:** \* Belzona® 4111 (Magma Quartz),

**Customer Location:** California water plant, U.S.A.  
**Application Date:** 1998

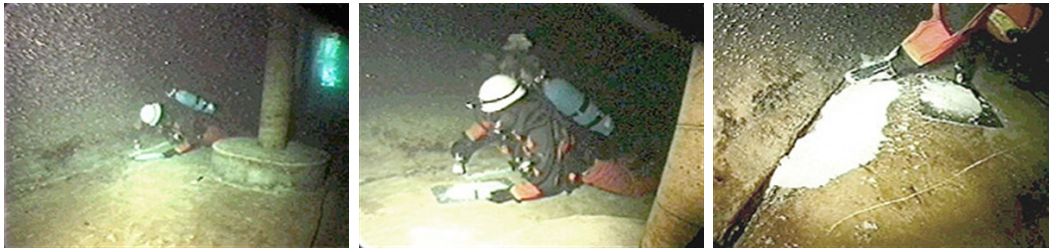
Various concrete cracks in the base of this aquaduct leaked copious amounts of water.

- \* Diver sent down to begin the application ,
- \* Diver utilizing a putty knife to force Belzona® 4111 (Magma Quartz) into concrete cracks ,
- \* Large section of spalled concrete repaired ,

The aquaduct could not be drained so the only alternative was to do an underwater application. The slurry version of the Belzona® 4111 (Magma Quartz) can easily wet out the concrete and even though adhesion is reduced, the repair was still a success.
