BELZONA BOAT LIFT TIRE REPAIR

ID: 35

Industry: *Marine*
Application: *SHM-Solids Handling Machinery*

Customer Location: *Boat Repair Facility in Florida*
Application Date: *February 1996*

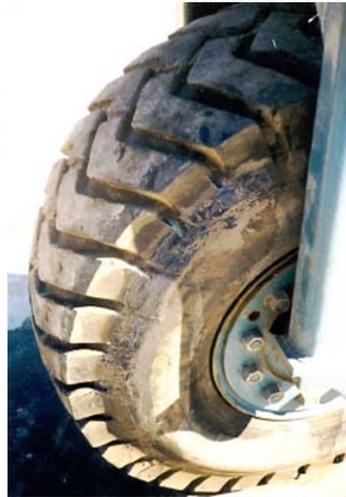
Tires on lift are actually retreaded aircraft tires. Delamination of the tire tread due to use and exposure to the sun.

- * View of boat lift used to hoist vessels from water ,
- * Tire tread is separating from the tire ,
- * Tire repaired with Belzona® 2311 ,

The application was carried out in accordance with a modified version of Belzona Know-How Leaflet SHM-9.

Tires cost approximately \$1,000 each. Two units of Belzona® 2311 (SR Elastomer) were used to repair the damaged area and to

protect the tire from future deterioration. More importantly, it improved the reliability of the boat lift. If the machine is down, this company could be out of business.
