# BELZONA BOAT LIFT TIRE REPAIR

ID: 35

Industry: *Marine*  
Application: *SHM-Solids Handling Machinery*

Drydock boat lift tire

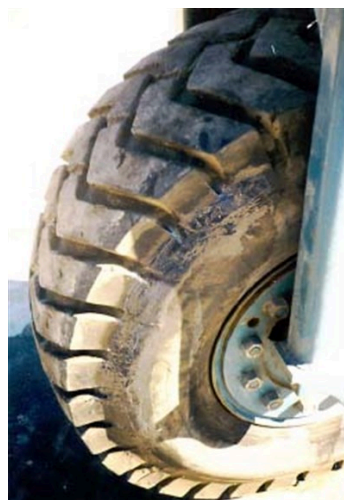
*Tires on lift are actually retreaded aircraft tires. Delamination of the tire tread due to use and exposure to the sun.*

- \* View of boat lift used to hoist vessels from water ,
- \* Tire tread is separating from the tire ,
- \* Tire repaired with Belzona® 2311 ,

The application was carried out in accordance with a modified version of Belzona Know-How Leaflet SHM-9.

Tires cost approximately \$1,000 each. Two units of Belzona® 2311 (SR Elastomer) were used to repair the damaged area and to

protect the tire from future deterioration. More importantly, it improved the reliability of the boat lift. If the machine is down, this company could be out of business.
