BELZONA RESTORES THIS FAN PUMP TO LIKE NEW CONDITION

ID: 350

Customer Location: Pulp and paper mill in Georgia, U.S.A.
Application Date: February 1986

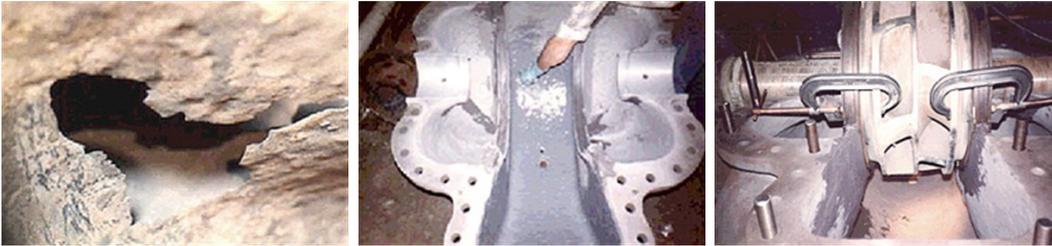
Photograph Descriptions

Extreme graphitization had caused holes between the suction and discharge sides of this fan pump after only four years of operation.

- * General view of casing showing graphitization and hole between suction and discharge sides ,
- * One half of the casing being rebuilt and resurfaced ,
- * Impeller in position to reform the case rings ,

The application was carried out in accordance with Belzona Know-How System Leaflets CEP-2, CEP-3 and CEP-5.

The complete application from beginning to end took only three days. The pump rehabilitation, including cost of labor, machinery and products was only 15% of the cost of a new casing.
