# BELZONA PROVIDES EROSION/CORROSION PROTECTION TO THIS POTABLE WATER TANK

ID: 353

Customer Location: *Power plant in Texas*  
Application Date: *July 1994*

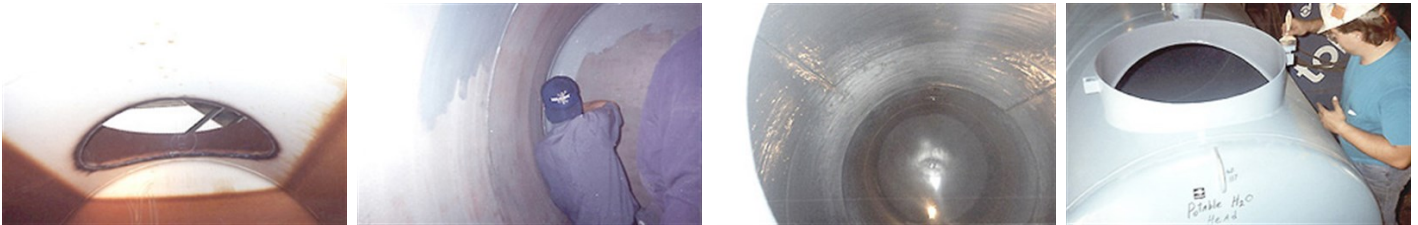
*Erosion-corrosion and blistering of original coating.*

- \* Internal view of the tank with corrosion evident ,
- \* First coat of Belzona® 1341 (Supermetalgilde) ,
- \* Application of Belzona® 1341 (supermetalgilde) complete ,
- \* Outside of tank coated with Belzona® 6111 and Belzona® 5111 ,

The application was carried out in accordance with Belzona Know-How System Leaflets TCC-3 and TCC-5.

The original tank coating failed after three years as a result of cold wall blistering. Belzona® 1341 (Supermetalgilde) NSF was used for erosion/corrosion protection. The product is certified to ANSI/NSF Standard 61 as acceptable for use in contact with drinking water.
