# BELZONA STOPS DAMAGE FROM OCCURRING AT NEW LOADING DOCK

ID: 354

**Industry:** General Industry  
**Application:** FPA-Floor Problem Areas  
**Substrate:** Concrete  
**Products:** \* Belzona® 4111 (Magma Quartz),

**Customer Location:** A welding supply customer  
**Application Date:** September 1990

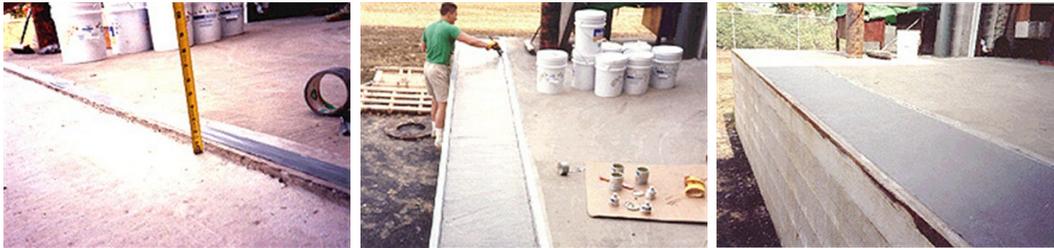
## Photograph Descriptions

- \* The recessed area of the dock ,
- \* The area taped and conditioned ,
- \* Belzona® 4111 (Magma Quartz) trowelled into place ,

As this was new construction, a recess two feet wide and one quarter inch deep was left the entire length of the 20-foot long loading dock. After the concrete was fully cured, this area was cleaned and prepared with Belzona® 4911 (TX Conditioner). Belzona® 4111 (Magma Quartz) was then trowelled into place at the edge of the dock. The application was carried out based on the company's previous experience with Belzona.
