BELZONA SAVES RETIREMENT RESIDENCE OVER \$7,000

Industry: *General Industry*
Application: *FBC-Fans, Blowers and Compressors*

Customer Location: *Retirement residence in Florida, U.S.A.*
Application Date: *October 1993*

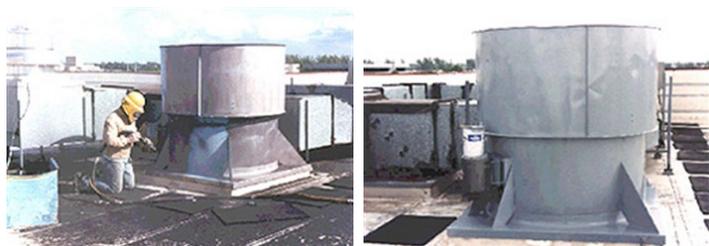
Photograph Descriptions

A six foot diameter exhaust fan is used in case of a fire to evacuate smoke from the burning building. The corroded metal shroud developed holes. Rainwater entered through the holes and caused water damage to the inside of the building.

- * Shroud grit blasted ,
- * Completed coating with Belzona® 5111 (Ceramic Cladding) ,

The application was carried out in accordance with a Belzona Know-How System Leaflets FBC-2 and FBC-4.

The cost of a new stainless steel shroud was \$9,600. The existing shroud was salvaged with approximately \$600 in products. Including blasting, the customer saved over \$7,000.
