# BELZONA REFURBISHES SETTLEMENT TANK AT WATER TREATMENT PLANT

ID: 3562

Damaged Primary Settlement Tank (PST) at water authority site

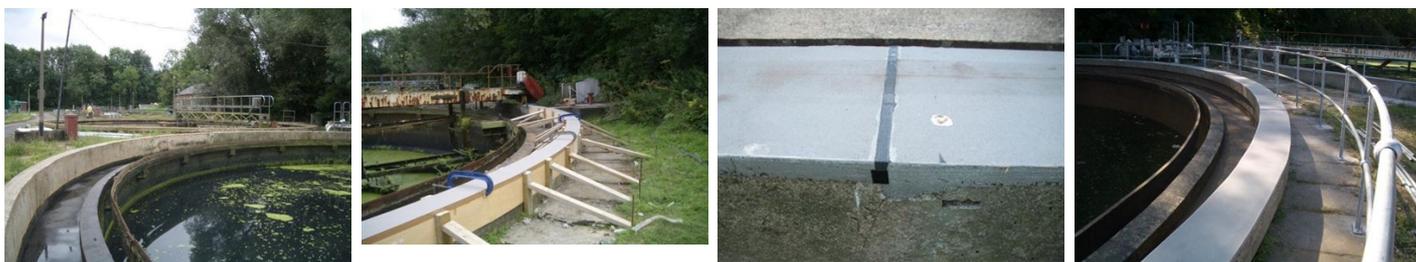
## Photograph Descriptions

Due to freeze thaw damage and the constant weight of the separator arm, many areas of the running track had become damaged.

- \* General view of the PST ,
- \* Forming boards being used during application of the Belzona® 4131 ,
- \* Expansion joint sealed with Belzona® 2211 ,
- \* Completed repair ,

Application was carried out in accordance with Belzona Know-How System Leaflets FPA-1 & FPA-6. Timber formers were fixed to ensure accurate levels were achieved.

This Belzona solution was chosen after many other repairs had failed. The Belzona® 4131 needed minimum cure time, minimum product quantity but offered maximum strength and abrasion resistance.
