BELZONA CREATES RUBBER LOBES ON THIS ROTARY PUMP

ID: 357

Industry: *Water / Wastewater*
Application: *PDP-Positive Displacement Pumps*

Customer Location: *Water treatment plant.*
Application Date: *1987*

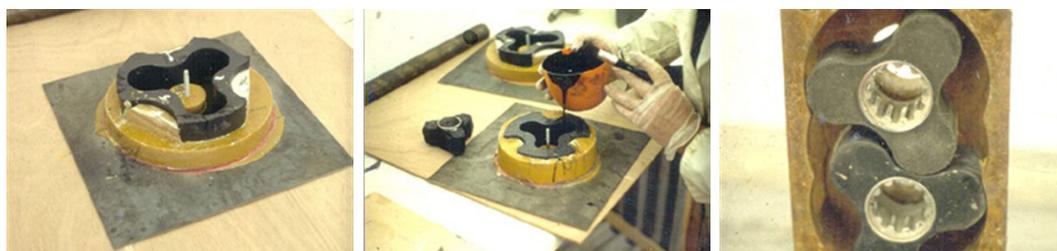
Photograph Descriptions

The two intermeshing rubber lobes in the pump rapidly wear and the clearances increase reducing the pumps efficiency. Replacement of the lobes is necessary but expensive and long lead times exist for replacement lobes from the manufacturer.

- * Mold prepared from new lobe ,
- * Pouring Belzona ® 2131 (D&A Fluid Elastomer) to fill the mold ,
- * Pair of lobes assembled in pump case housing ,

The Belzona repair scenario allows replacement lobes to be produced at a considerable reduction in cost over new units from the manufacturer. This alternative also provides extended service life.
