# BELZONA® GETS THE NOD WHEN DOWNTIME MUST BE MINIMIZED

Customer Location: Geothermal Plant in the Philippines.

Application: TCC-Tanks and Chemical Containment Areas

Anchor casing

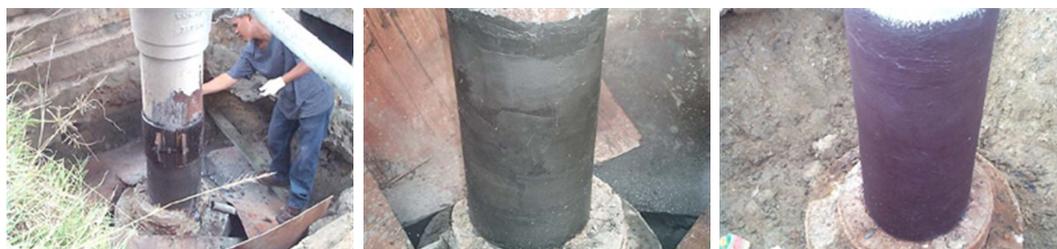
*This anchor casing was badly in need of repair. Plant engineers did not want to shut down the equipment, leaving Belzona's heat-activated products as the only viable option.*

\* Pitted areas are rebuilt with Belzona® 1251 prior to Belzona® 5851 application. Belzona® 1251 is heat cured in service with adhesion strength of 3200 psi. Final coat of Belzona® 5851 for extra protection. ,

Manual surface preparation was used. Next, a new metal jacket was placed over the heavily pitted areas and bonded in place with Belzona® 1251. After the material began to cure, Belzona® 5851 was used to coat the entire area for extra protection.
