CORRODED PIPEWORK: A THING OF THE PAST WITH BELZONA® 5851 (HA-BARRIER)

ID: 361

Customer Location: Oil refinery in New Zealand

Application: TCC-Tanks and Chemical Containment Areas

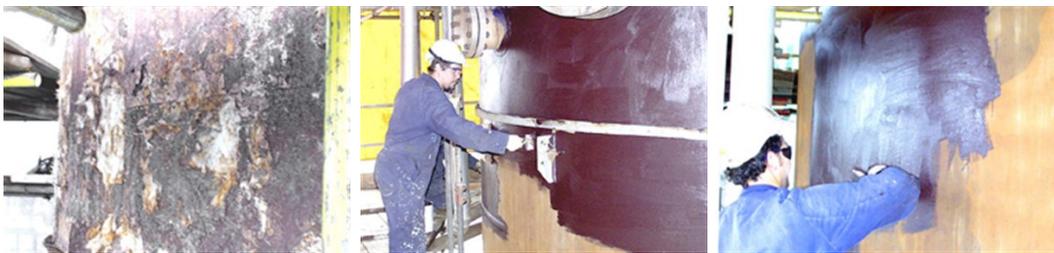
Photograph Descriptions

CUI (Corrosion Under Insulation) was causing costly shutdowns to under-take repairs.

* Prior to application, corrosion can easily be seen. Belzona® 5851 (HA-Barrier) is easily applied to hot surfaces by trowel, brush, or even spray. ,

Manual surface preparation was done with high pressure water blasting. Belzona® 5851 (HA-Barrier) was applied directly to hot pipework while in service.
