COLD BONDING WITH BELZONA OFFERED ALTERNATIVE REPAIR TO PENSTOCK

ID: 3617

Customer Location: Hydro Power station, UK
Application Date: March 2006

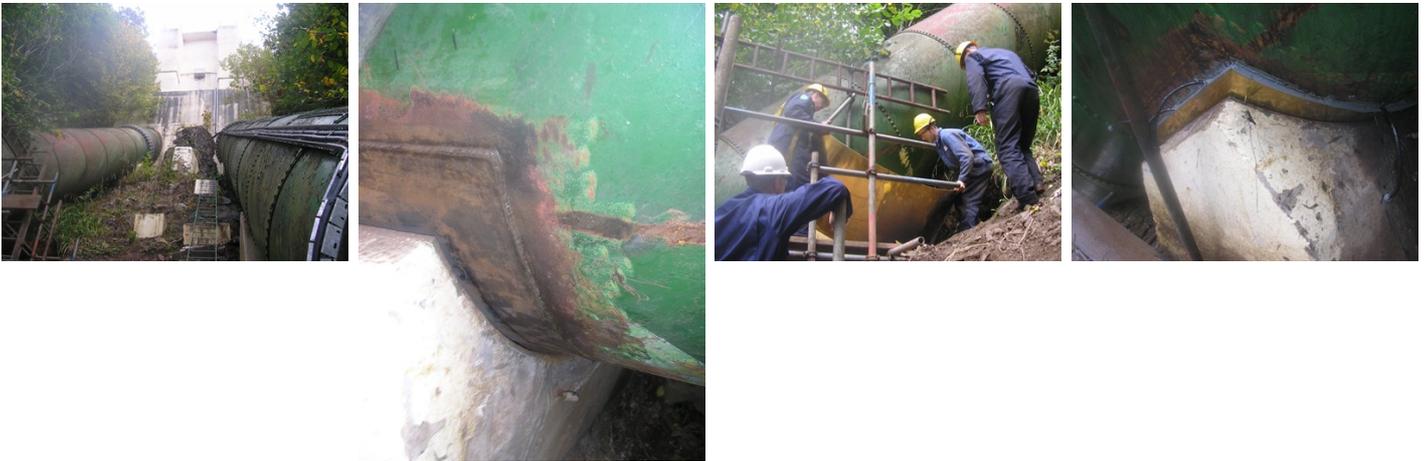
Photograph Descriptions

The penstock had been weld repaired and due to the nature of hot works, the penstock had deformed and created a void between the penstock pipe and the concrete support pad. The Hydro power station would not accept the void between penstock and the pipe support and informed the contractor they would need to rectify the problem before signing the job off.

- * View of the penstock ,
- * View of the pipe support 3. Brass plate being put into place ,
- * Application completed (Belzona® 1211 on the edges, Belzona® 5811 injected in the void) ,

Application was carried out in accordance with Belzona Know-How System Leaflet GSS-9. Edges of brass plate were sealed to penstock with Belzona® 1211. Void between penstock and plate was then filled with Belzona® 5811 using injection equipment.

The repair was done on site, in a short time. The injection technique used in this application ensured that there is no void between the brass plate and the penstock, eliminating any galvanic or crevice corrosion. Belzona application remained effective until entire penstock had to be replaced.
