CAR PARK REPAIRS WITH BELZONA

ID: 3619

Customer Location: Local authority, Blackpool, England
Application Date: October 2011

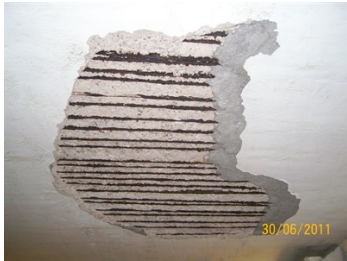
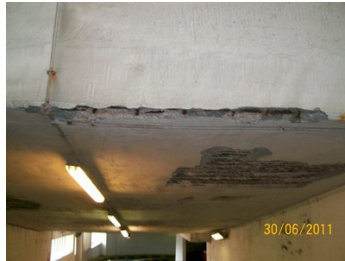
Carbonation of the reinforced concrete had led to extensive spalling on ceilings and walls, which required urgent repair.

- * 1 & 2. Severe spalling on ceilings ,
- * 3 & 4. After: Belzona® 4141 applied to the overhead surfaces ,

The material's fast cure meant that the parking deck was reopened with minimum disruption and the repairs could be directly over-painted after just 3 days, which was the amount of time required to complete the concrete repair. The council selected Belzona as their first choice due to previous successful work undertaken for the council on another city car park.
