BUGSTRAHLGETRIEBE MIT BELZONA REPARIERT

ID: 3637

Standort des Kunden: Lloyd Werft, Bremerhaven, Deutschland
Antragsdatum: März 2011

Winkelgetriebe des Bugstrahlruders eines Frachtschiffs.

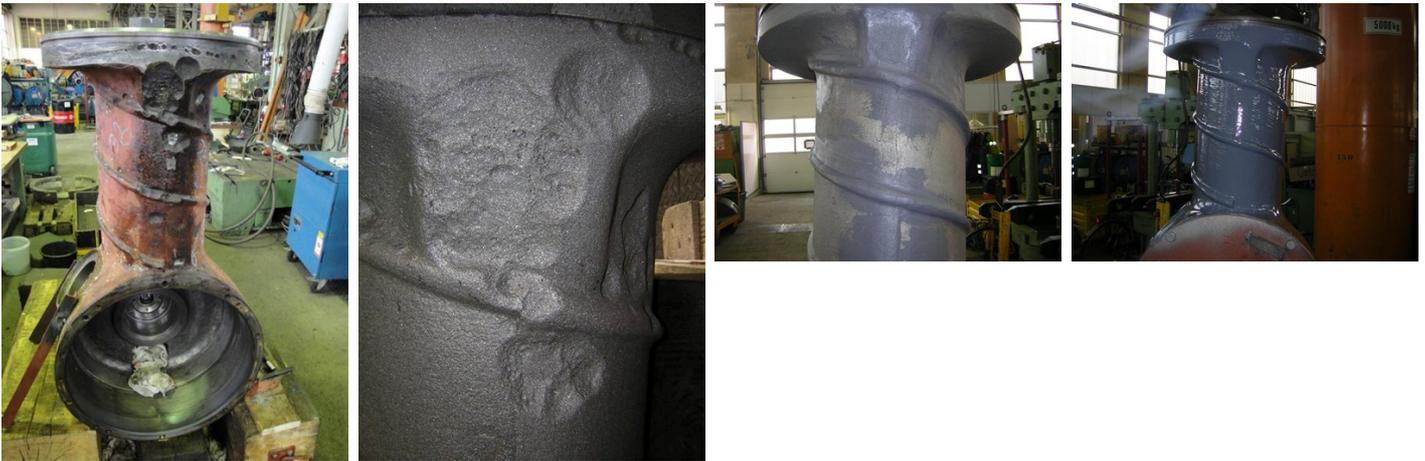
Fotobeschreibungen

Das Winkelgetriebe wies schwere Schäden am Gehäuse auf.

- * 1. Das Ausmaß der Schäden ist klar erkennbar ,
- * 2. Nahaufnahme nach dem Sandstrahlen ,
- * 3. Anwendung in Gang ,
- * 4. Abgeschlossene Anwendung ,

Industrie: Marine
Anwendung: Schiffe und Offshore-Strukturen
Substrat: Grauguss
Produkte: * Belzona 1311 (Ceramic R-Metal) ,
* Belzona 1321 (Ceramic S-Metal) ,
* Belzona 4311 (Magma CR1) ,

Die Anwendung wurde gemäß dem Belzona Know-how System Infoblatt SOS-2 durchgeführt.
