BELZONA REPAIRS FLOATING HOSES

ID: 3640

Industry: *Marine*
Application: *SOS-Ships and Offshore Structures*

Customer Location: *Port authority, Wilhelmshaven, Germany*
Application Date: *March 2011*

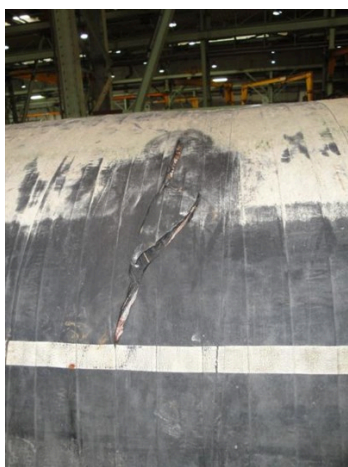
Dredger damage to the floating hoses.

- * Close-up of damage ,
- * Surface preparation roughening ,
- * Completed application including use of stainless steel screws to hold the repair in place ,
- * Performance test (24 hours) ,

The repair was carried out using a modified version of SOS-12. Surface preparation consisted of roughening the surfaces prior to the application of Belzona® 2911. A rubber mat was bonded over the damaged area with Belzona® 2211, using stainless steel screws to hold the repair in place.
